AGARD REPORT No. 716

Composite Structure Repair

AGARD Report No.716
COMPOSITE STRUCTURE REPAIR

Larry G. Kelly
AFWAL/FIBC
Wright Patterson AFB
OH 45433
USA

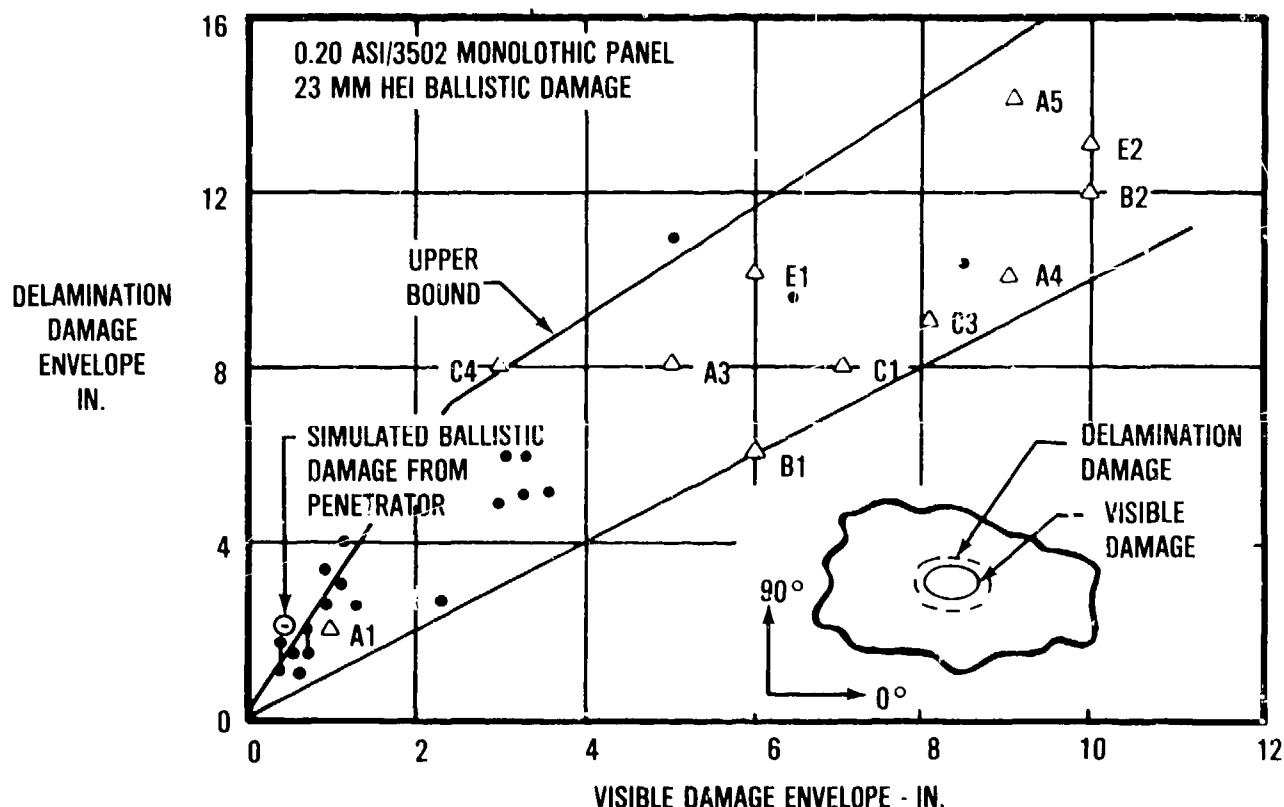
Figure 3. Ballistic Damage to Carbon Epoxy Panels

Ultrasonic equipment is the most widely used and is generally employed with a set of standards for set up and defect comparison. Figure 3 compares size of visible damage to area of internal delaminations as determined by ultrasonics. This data is from Reference 1 and is for a wide range of carbon panel types; some with buffer strips and stitching to contain delayed and superquick fuzed 23 mm high explosive projectile damage. The original data is from McDonnell Aircraft but I have included data from Boeing, Northrop and Air Force reports (dots and bars). This data includes impacts of fragments (1/4, 3/8, 1/2 inch) and projectiles (12.7, 14.5, 23 mm) with angles of obliquity up to 60 degrees.

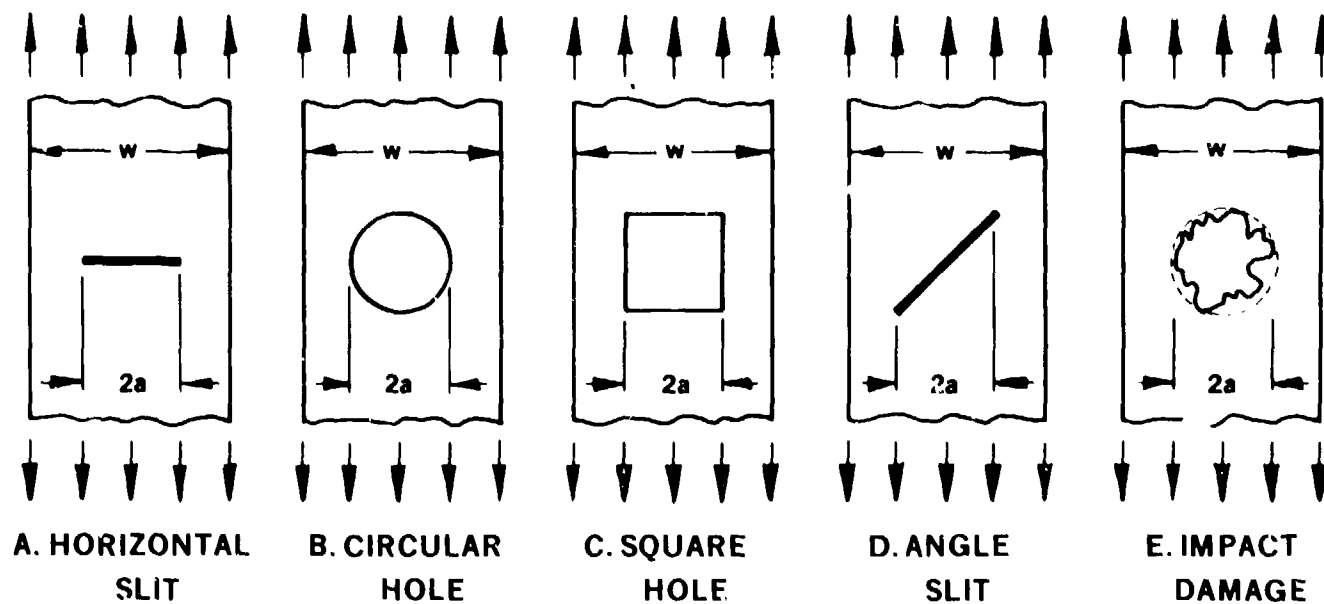
Figure 4. Examples of Through-Thickness Defects Having Same Tension Failure Loads

Some test results, Reference 2, indicate that for a given panel width and laminate orientation various through-the-thickness crack geometries having the same crack width, as shown in Figure 4, failed at essentially the same tension load. Thus assuming damage to consist of a through-the-thickness defect equal in width to the maximum damage dimension (as determined by ultrasonics) perpendicular to the primary load path, linear elastic fracture

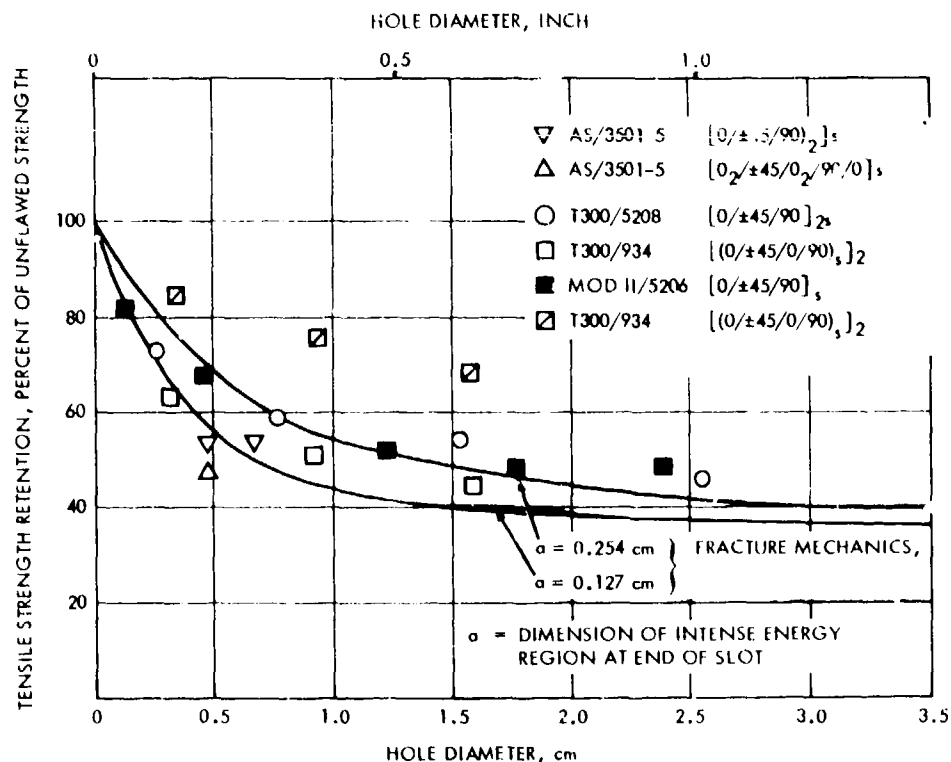
Figure 5. Tensile Strength Retention of Laminates with a Hole

Figure 5, from Reference 3, shows that there is substantial strength loss in carbon composites with relatively small holes.

Current design practice in the U.S. is to limit ultimate strain allowables in carbon composite structures to approximately 3500-4500 μ in/in. This allows for stress concentrations due to bolt holes or notches and provides for some accommodation of strain concentrations due to defects or damage. The figure 5 data does, however, point out the need for good quality repairs with substantial load carrying capability especially for structures designed with higher strain allowables.

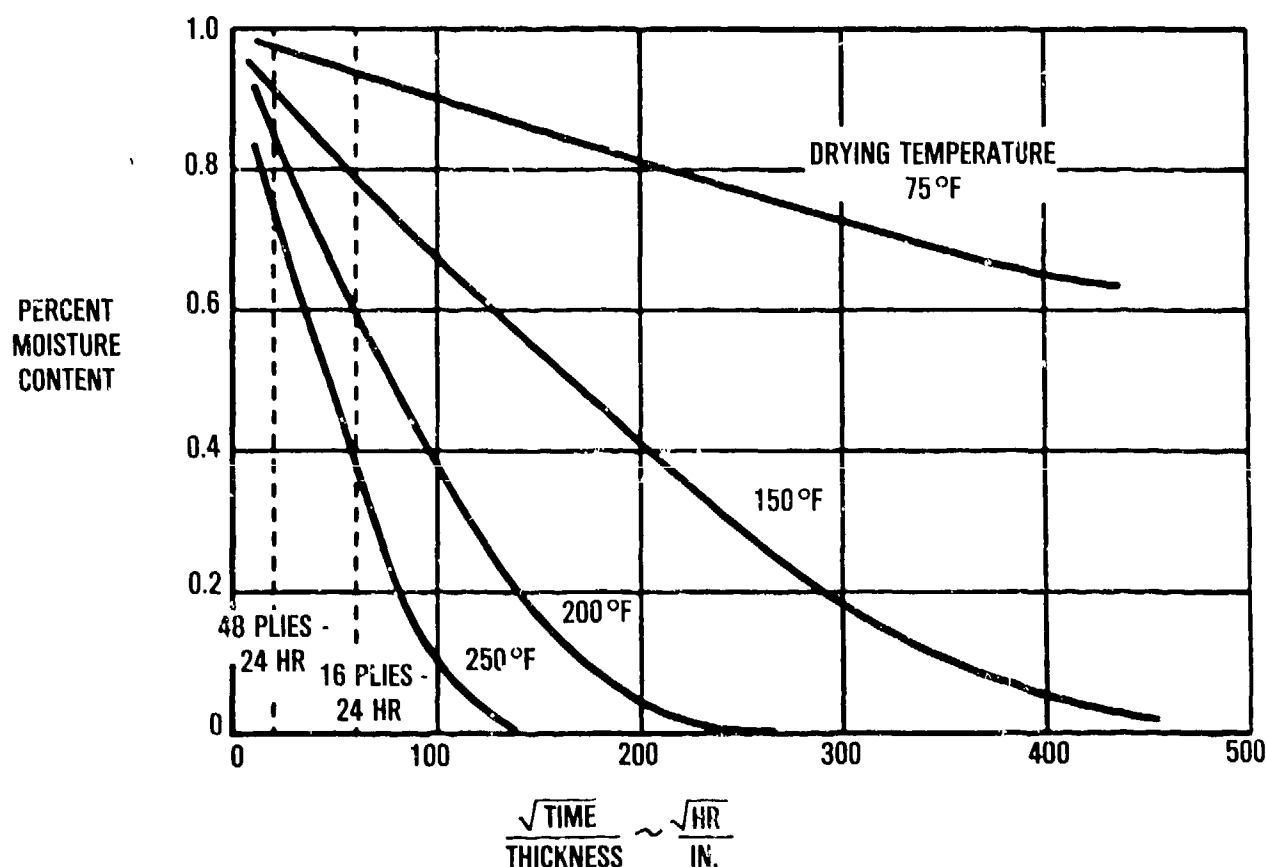
Figure 7. Drying Time for Carbon Epoxy Laminates

Prebond drying (a minimum of 48 hours at 170°F-200°F), slow heat up rates, reduced cure temperatures and selection of adhesives less sensitive to moisture can minimize or eliminate the above problems. The 250°F curing adhesives, as a group, are more sensitive to prebond moisture at higher temperatures (above 150°F) than 350°F curing adhesives. Drying the parent laminate to an average moisture content of less than .5 percent is recommended. This can be very time consuming taking over 24 hours for a 16 ply laminate, as shown in figure 7.

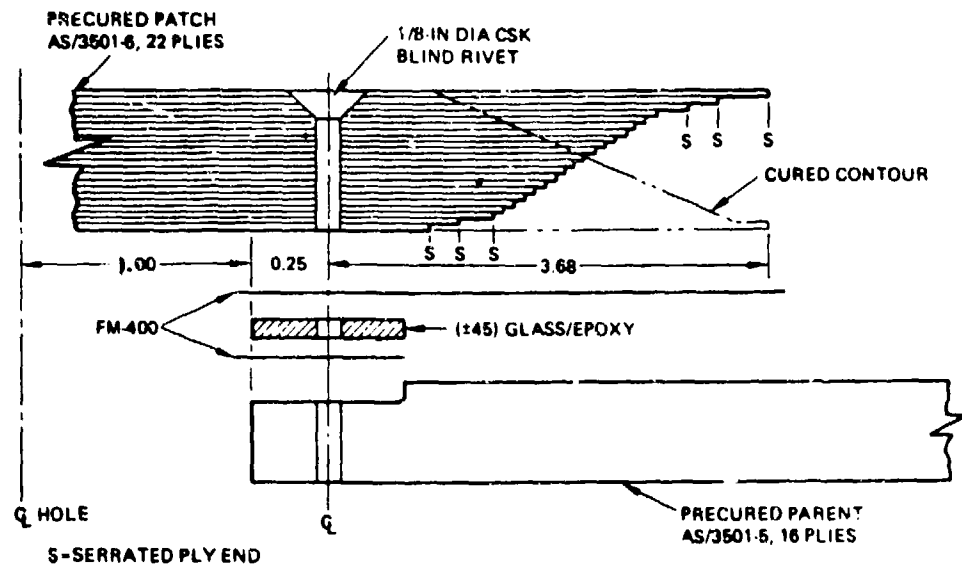
Figure 9. External Patch Repair

Applying this concept to 2" diameter holes in four-point-load sandwich beams obtained the results shown in Table 1. Figure 9 shows the details of the 22 ply patch design. Comparing the resulting failure loads with the parent allowables quite satisfactory results were obtained for low to intermediate load levels (6-7,000 lb/inch).

Having established the capability of composite scarfed joints to satisfactorily transfer the required loads, the application of this repair concept (Figure 11) and that of the precured external patch (Figure 9) was applied to the repair of 4 inch diameter holes in 12 inch by 48 inch panels (Figure 12).

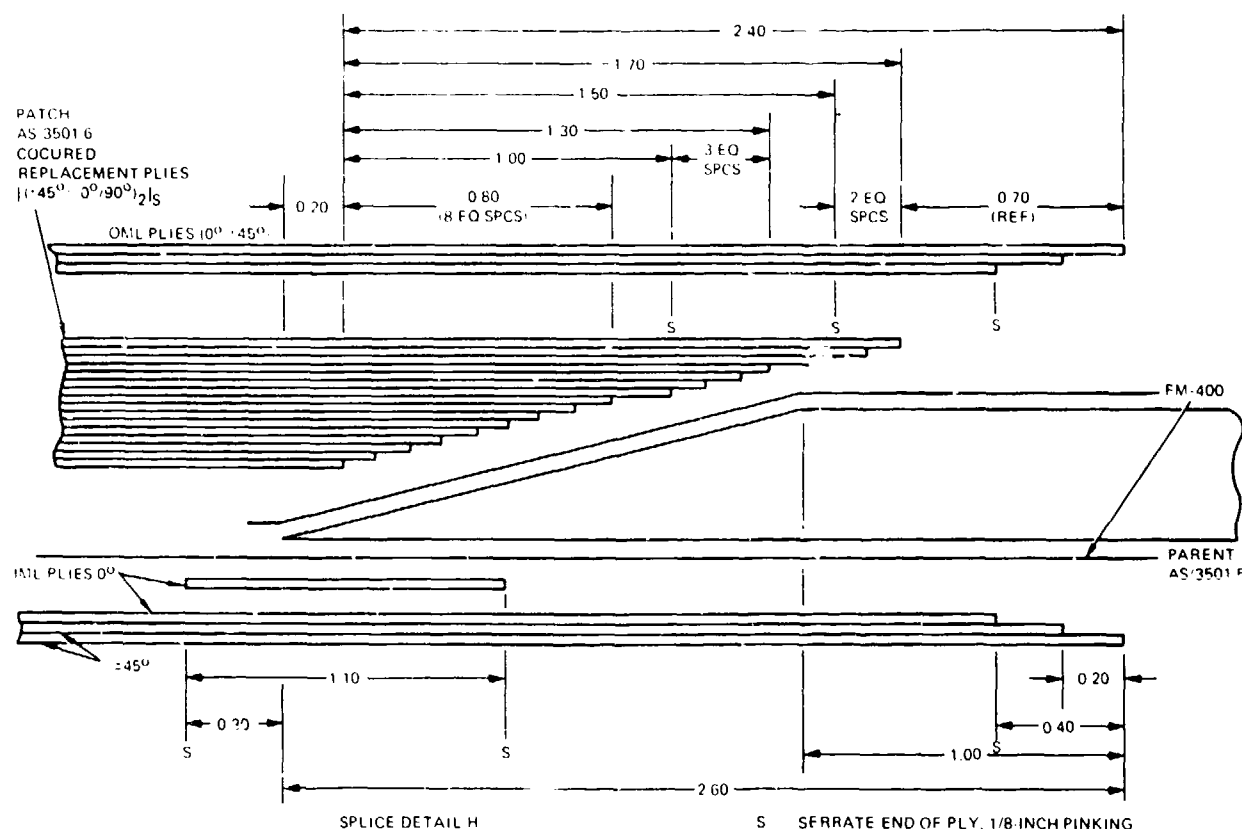
Figure 11. Flush Scarf Repair

Repairs up to 100 inch sq. in 16 and 24 ply laminates have restored 80-100 percent of the parent laminate allowable utilizing the techniques described above. This has been verified through a series of repair joint coupons, sandwich beams, flat panels and box beam tests. First 1" wide tension coupons and compression sandwich beam specimens of the scarf design shown in Figure 11 were tested with the results shown in Table 2.

The test results shown in Table 2 are for specimens consisting of a parent laminate of AS/3501-5 $[0/+45/90]_2$ that was scarfed over a length of 1.6 inches and a patch laminate of AS/3501-6 plies, per Figure 11, that was cocured and bonded to the scarf. Comparing the failure loads for these joints to that of the parent laminate allowable, quite satisfactory joint load transfer efficiencies were achieved.

(a) Splice details shown in Figure 11.

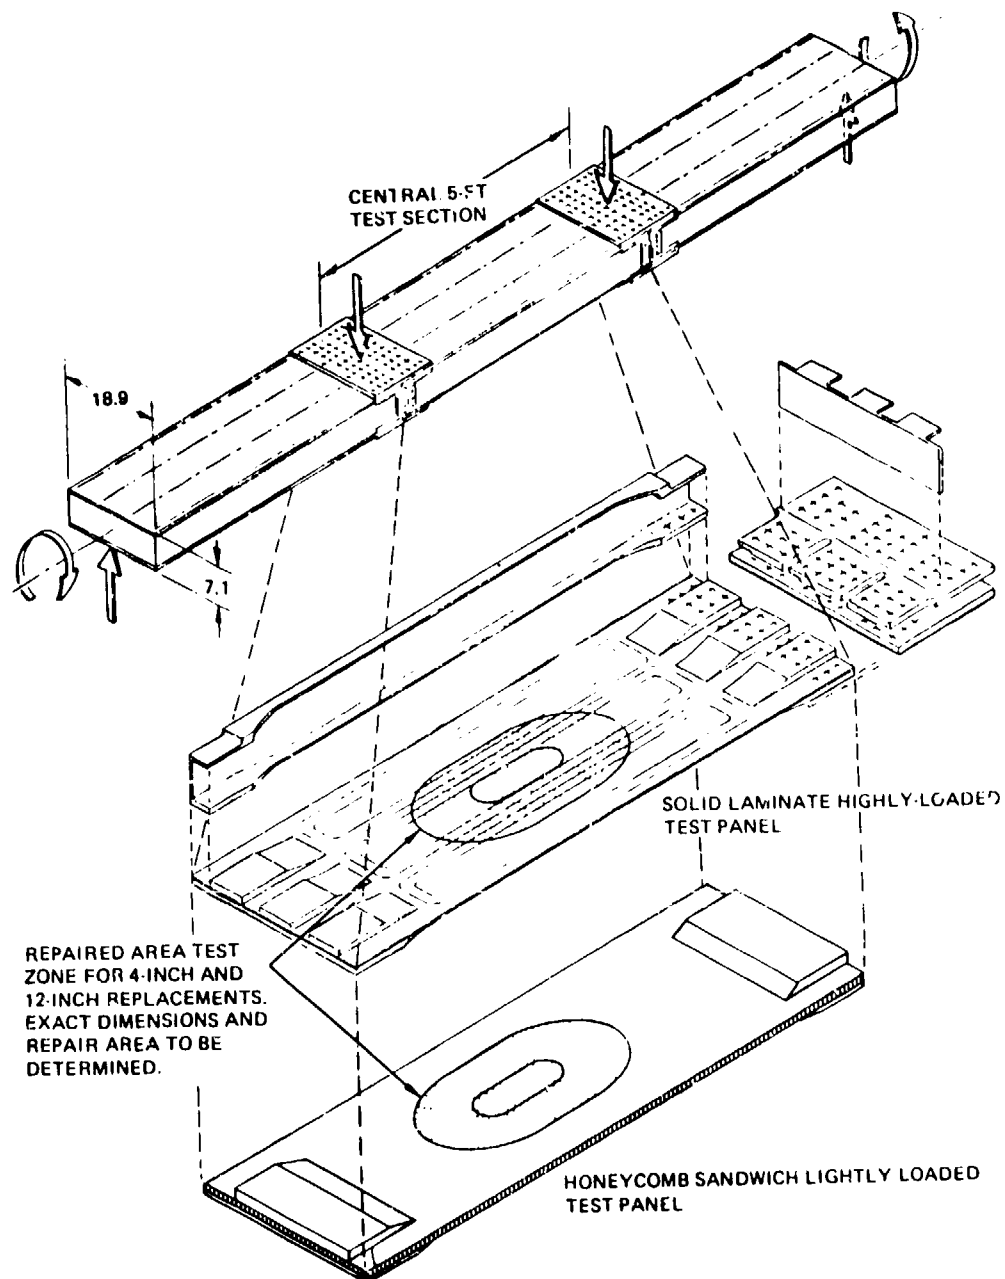
Figure 13. Large Scale Demonstration Panel
Box Beam Test Fixture

The final demonstration of the repair concept developed was accomplished through the use of a 17 foot long, 19 inch wide, 7 inch deep box beam to which four point bending and torsion loads can be applied to the tension cover of a five foot test section, Figure 13. The five test panels and repair techniques utilized are outlined below:

- Panel 1. Honeycomb Sandwich Panel (8 ply laminates on .5 inch thick aluminum core)
 Damage: 6" x 12" oval hole completely through after clean up
 Repair: 13 ply bonded cocured scarf patch to both facesheets (36:1 taper) + core plug
- Panel 2. Honeycomb Sandwich Panel (8 ply laminates on .5 inch thick aluminum core)
 Damage: 6" x 12" oval hole after clean up on front face and a 1" x 6" hole on the back face
 Repair: 5 ply precured blind side patch + 13 ply bonded cocured scarf patch for inner and outer faces + core plug

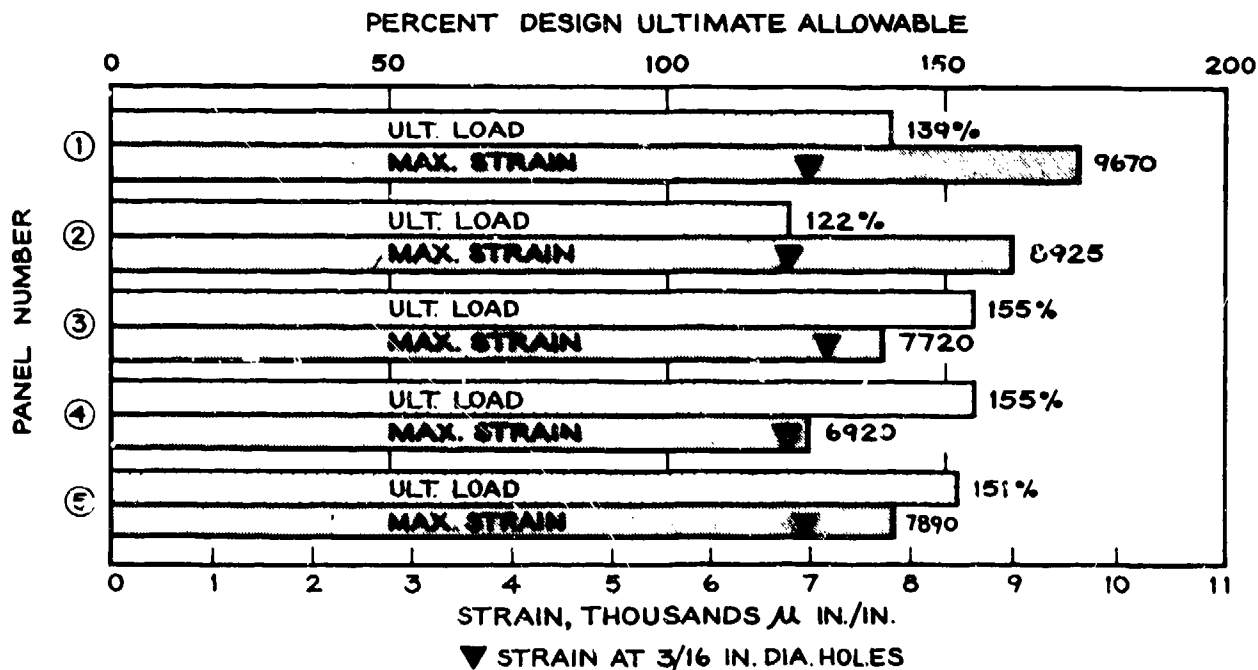
Figure 14. Demonstration Panel Results

Test results for these five panels are shown in Figure 14 and summarized below. More details on these test results can be found in Reference 6.

Panel 1. Failure was remote from the patch area at 139% of the parent ultimate tension allowable at a failure load of 2390 lbs/inch

Panel 2. Failure was through the repaired area at 122% of the parent ultimate tension allowable at a failure load of 2095 lbs/inch

Panel 3. Failure was remote from the patch area at 155% of the parent ultimate tension allowable at a failure load of 14,200 lbs/inch

Panel 4. Failure was through the repaired area at 155% of the parent ultimate tension allowable at a failure load of 14,200 lbs/inch

Panel 5. Failure was remote from the repaired area at 151% of the parent ultimate tension allowable at a failure load of 19,300 lbs/inch
